# **Lost, A Desert River and Its Native Fishes: A Historical Perspective of the Lower Colorado River**

Information Technology Report  
USGS/BRD/ITR--2002--0010  
December 2002

By  
Gordon A. Mueller  
Paul C. Marsh

U.S. Department of the Interior  
U.S. Geological Survey

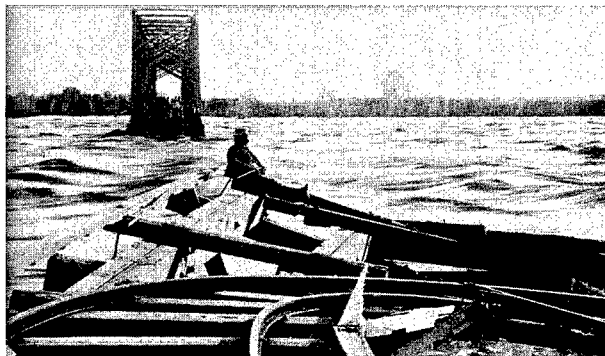
Fig. 11. Photograph of the Salt River flood of 1890. Courtesy of the Bureau of Reclamation, Boulder City, Nevada.

Settlers around the Salt and Gila Rivers reeled from a huge flood in 1890 (Figs. 11 and 12). Blake (1915), a

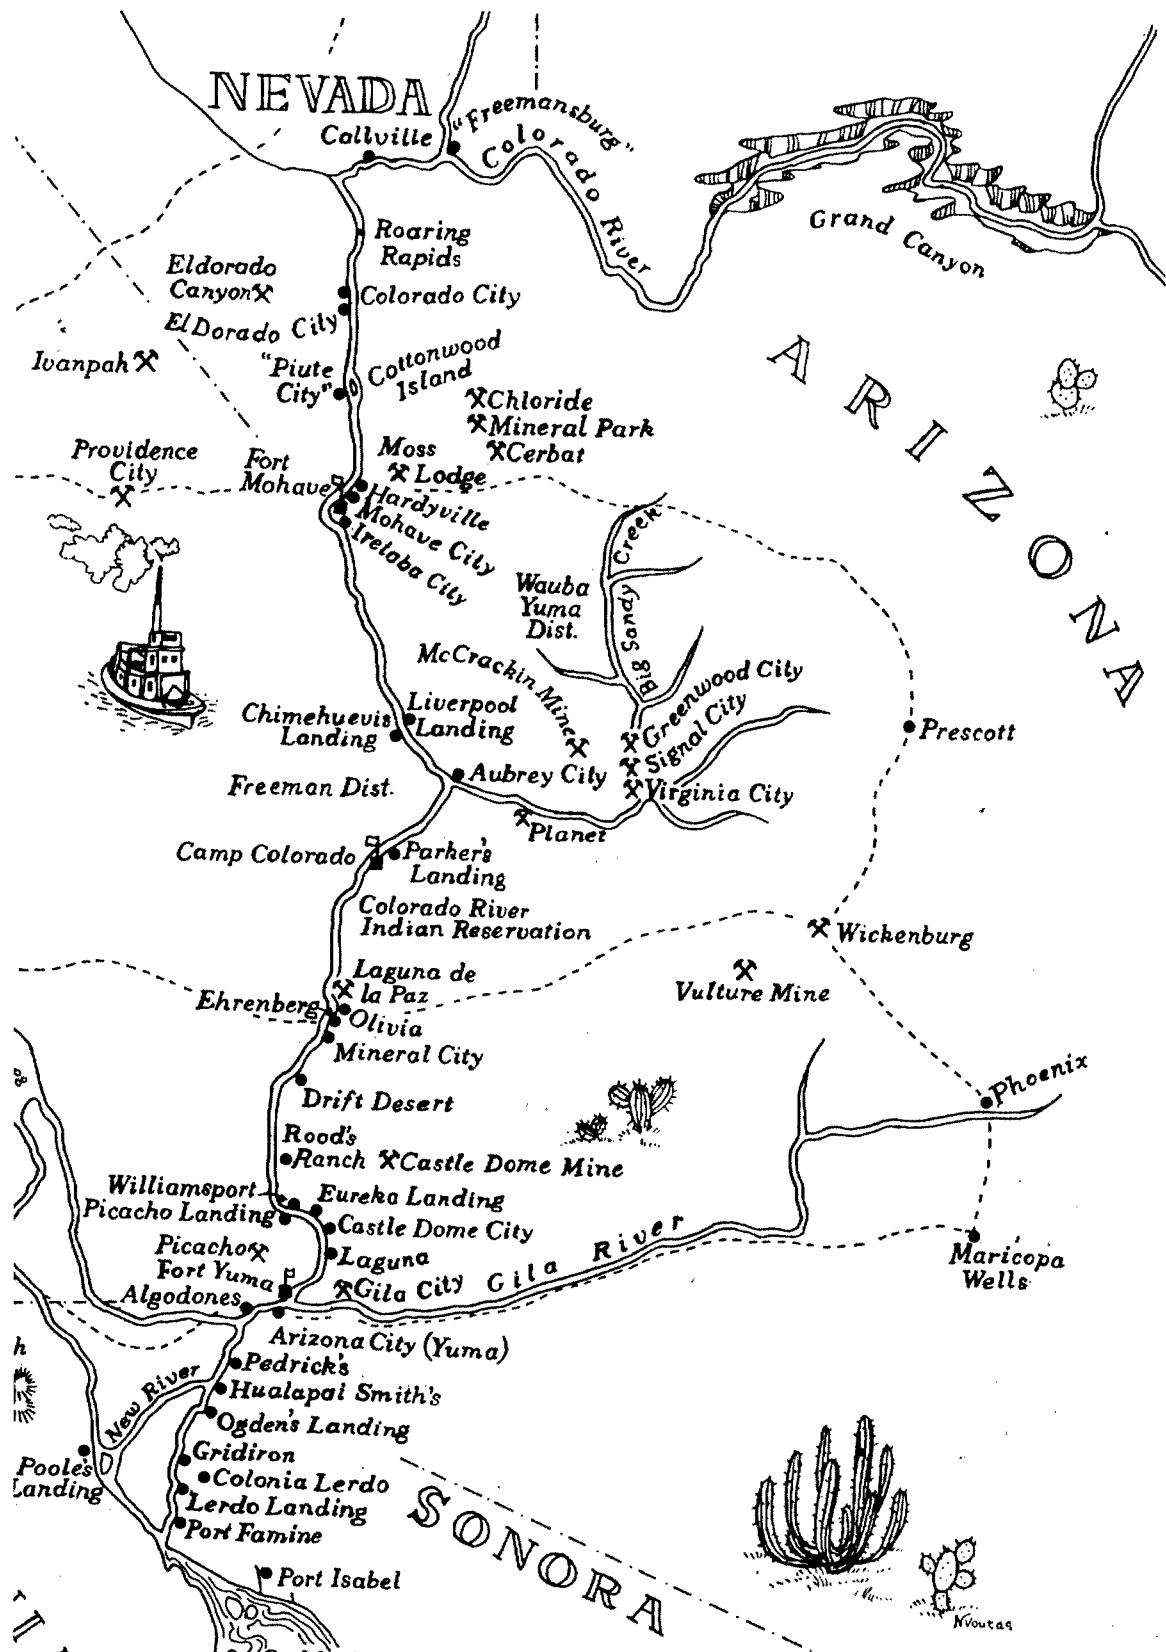
Fig. 15. Map showing steamboat landings on the Colorado River between 1860 and 1870. Courtesy of R.E. Lingenfelter (1978).

hungry boilers (Fig. 15). Additional landings upstream of Yuma soon appeared, including Laguna, Castle Dome City, Eureka Landing, Williamsport, Rood's Ranch, Drift Desert, Mineral City, Olivia, Ehrenberg, Parker's Landing, Mellen, Hardyville, Camp Eldorado, and Callville.

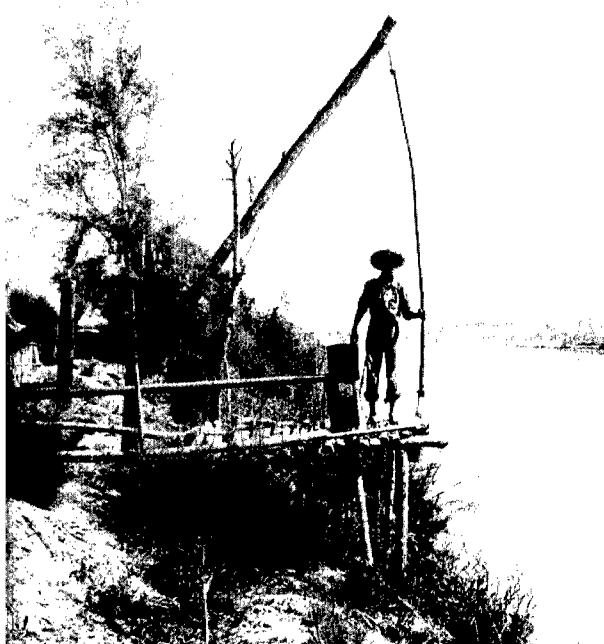
Fig. 18. Primitive water lift believed to have been located in the Colorado River delta (date unknown). Courtesy of the Bureau of Reclamation, Yuma, Arizona.

Human use of the river started modestly. Tribal societies began to garden and then developed larger farms (Fig. 18). The Anasazi farmed hundreds of acres along the Salt and Gila River Basins more than 1,000 years ago. Around Phoenix, archeologists have uncovered extensive irrigation systems that include small storage reservoirs and hundreds of miles of ancient canals. These may well represent the single largest acreage irrigated by

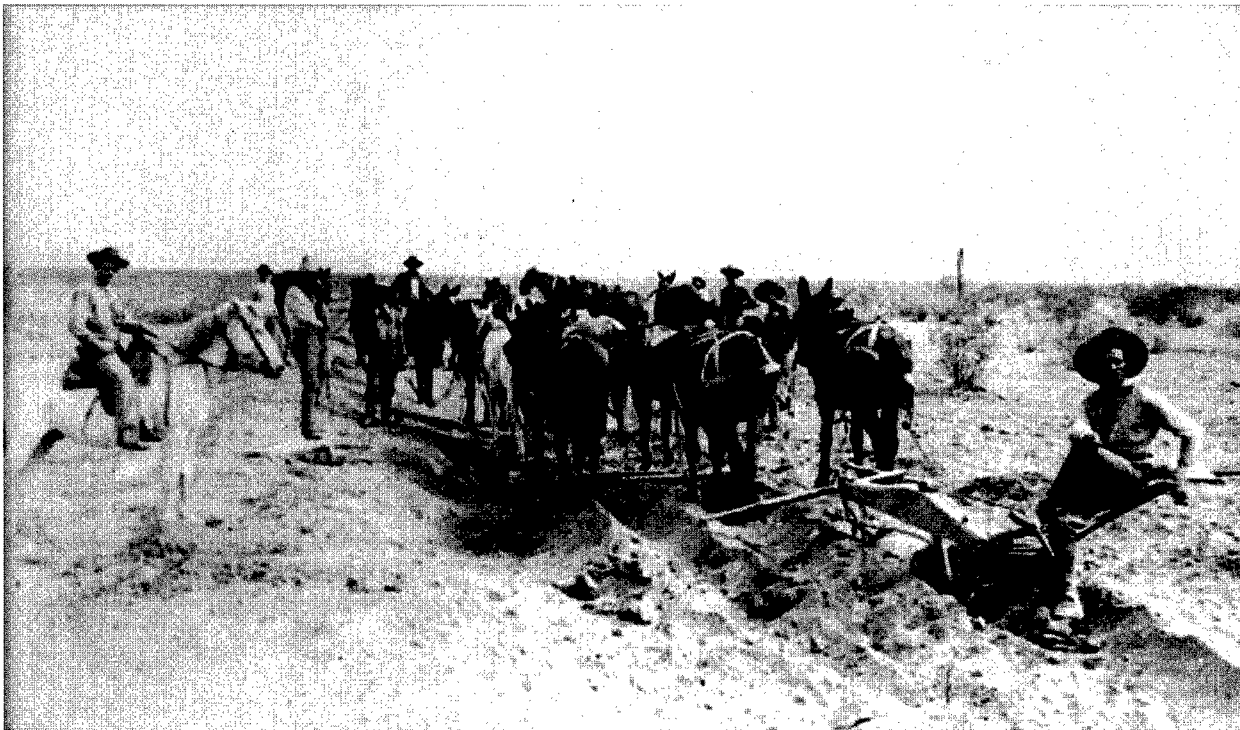
Fig. 19. Early settlers using horse-drawn plows to help dig the first irrigation canals. Courtesy of the Arizona Historical Society, Tucson.

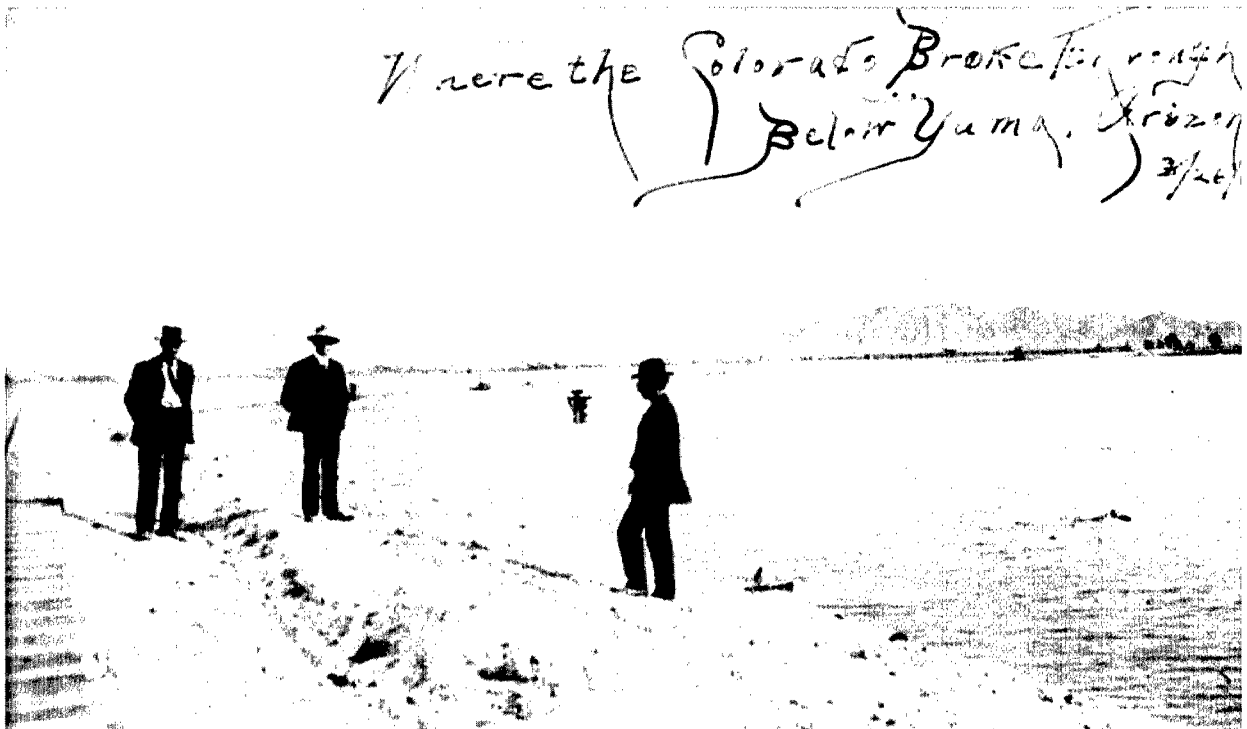
Fig. 21. The location where the Colorado River broke through its levee in 1905, AHS 62340. Courtesy of the Arizona Historical Society, Yuma.

The most notable of these events occurred in 1905 when the Colorado River broke through its levee and left

its channel and flowed uncontrolled into the Salton Sink until the levee was repaired in 1907. While the river was returned to its original channel, irrigation drainage continued to flow down these flood ways as more river water was diverted toward the Imperial and Coachella Valleys. Flood waters once again entered the Salton Sea in June 1914 when the spring flood broke through the Volcano Lakes Levee in Mexico and flowed north through the New River. Maximum flow during that short event was only 6,000 cfs.

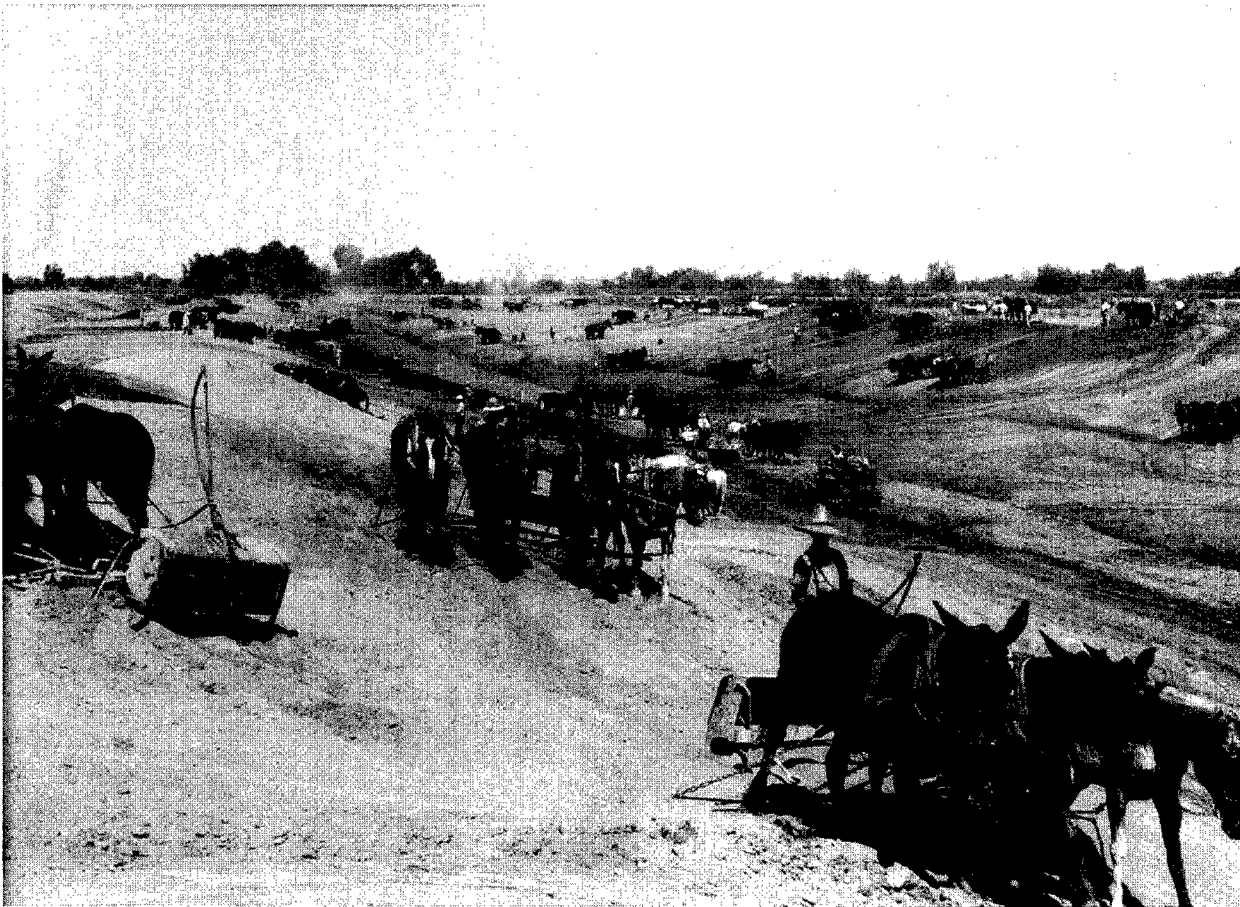
Fig. 22. Horse and mule-drawn scrapers help dig the All-American Canal in 1935, P212-303-269A. Courtesy of the Bureau of Reclamation, Boulder City, Nevada.

Further upstream, Hoover Dam was built to capture and store floods. Concurrently, Imperial Dam was being built to divert those waters, and the All-American Canal was being built to carry those waters to fields in Southern California (Fig. 22).

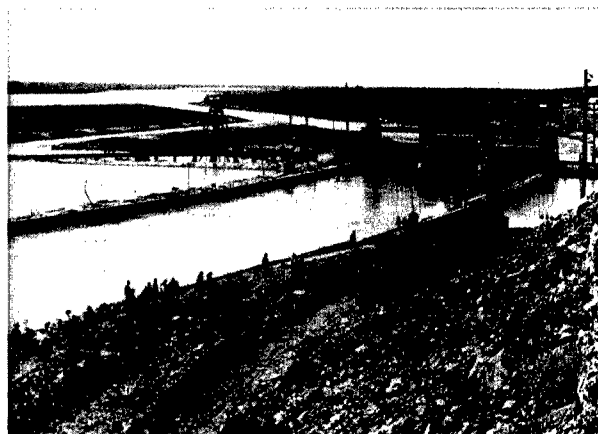
Fig. 27. Laguna Dam was built in 1909 and was the first man-made structure to span the Colorado River, P45-300-4374. Courtesy of the Bureau of Reclamation, Boulder City, Nevada.

Kolb (1927) had to portage over Laguna Dam which had been constructed in 1909 as the first manmade diversion to span the entire river. His journal continued: "In another place there were no banks, and the water had spread for three miles in broken sloughs and around half-submerged islands, the one deep channel being lost in the maze of shallow ones...Once I lost my way and spent a half hour in getting back to the right channel [Kolb, 1927]."

Arizona. Two others were built on the Gila River. Laguna Dam, built in 1909 on the lower Colorado River mainstem, sparked the construction of seven major structures on the Colorado River. Additional dams can be found on the Bill Williams, Las Vegas Wash, and Quail Creek, a major tributary of the Virgin River.

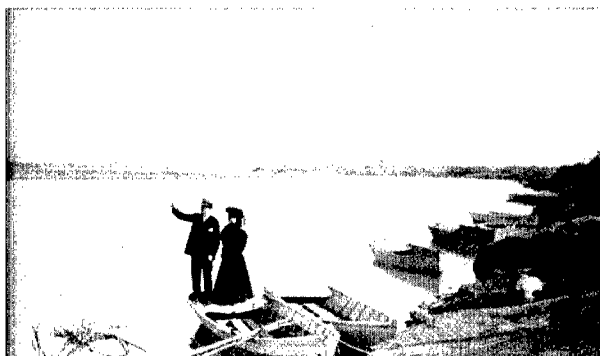
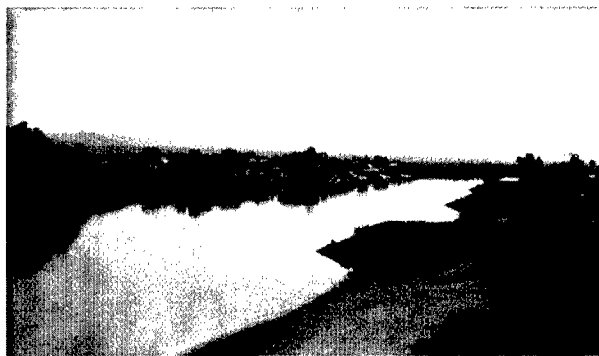
**Fig. 36.** Comparative photographs (1908 and 2001) taken of the Colorado River at Needles, California. 1908 photograph courtesy of the Mohave County Historical Society.

Looking at the river today, it is difficult to imagine the Colorado River being nearly 2 miles wide (Fig. 36). The wide expanses of flat, dry floodplain and irrigated farmland is a testament to the effects of human intervention. At one time steamboats ran along the Arizona shoreline to deliver freight to the mining camps around Oatman, Arizona. The old riverboat landing was nearly 4 miles east of the current river channel where 150-foot steamboats delivered thousands of tons of freight and transported ore to stamp mills. The last remnants of the wooden landing were destroyed a few years ago by a brush fire.

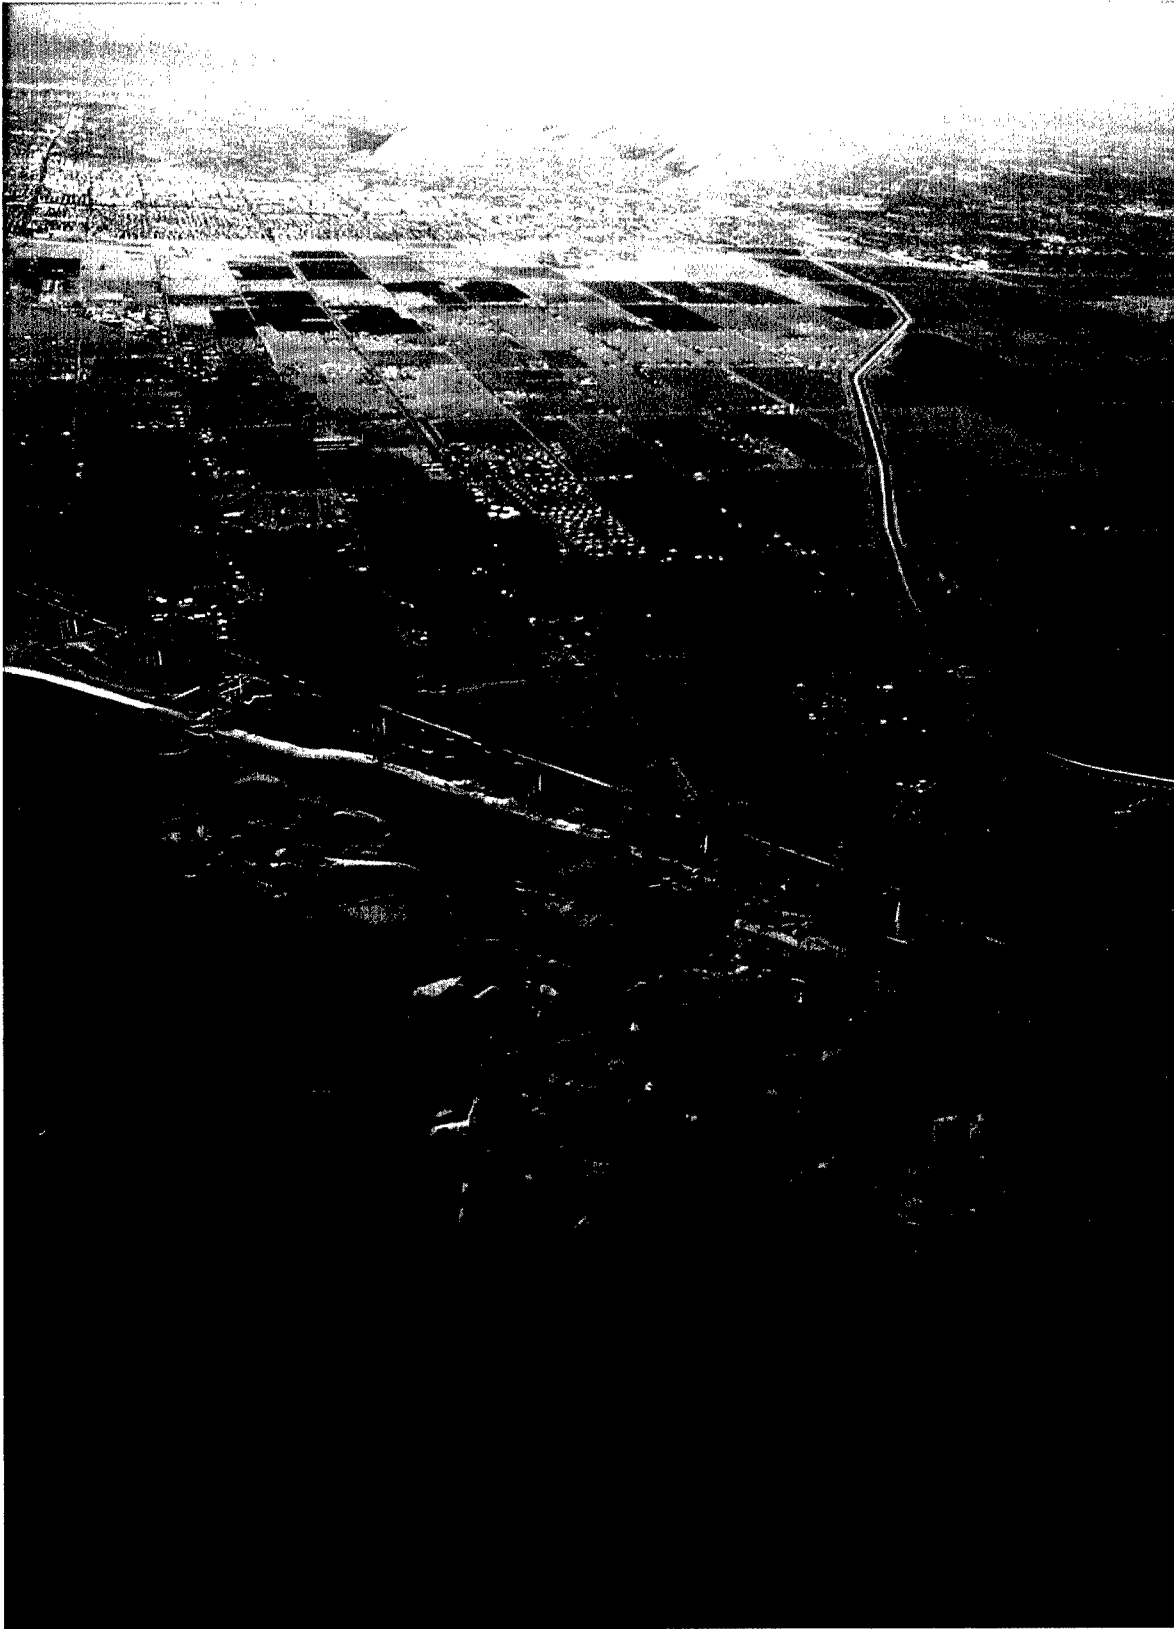
**Fig. 41.** Aerial view of the Salt River floodplain near Phoenix, Arizona. Photograph by Michael Collier.

Similar changes have occurred to tributary streams. Historically, surface flow often became intermittent or totally dried up in the stream's lower reaches. Today, that condition has not only intensified but has become permanent. Upstream water storage on the Bill Williams and Gila Rivers has dried up the lower portions of these streams. On the Salt and Gila Rivers, Roosevelt, Horse Mesa, Mormon Flat, Stewart Mountain, Bartlett, Horse-shoe, and Coolidge Dams capture water that historically flowed to the Colorado River and delta. The river channel through the "Valley of the Sun" is normally dry except for a few deep ponds left behind from sand and gravel mining and an incongruous, 2-mile-long artificial lake. The river corridor is leveed and highly disturbed, forming little more than a scar across the valley and state (Figs. 41 and 42). Recent maps seldom show sections of these streams, testifying to their conspicuous absence.

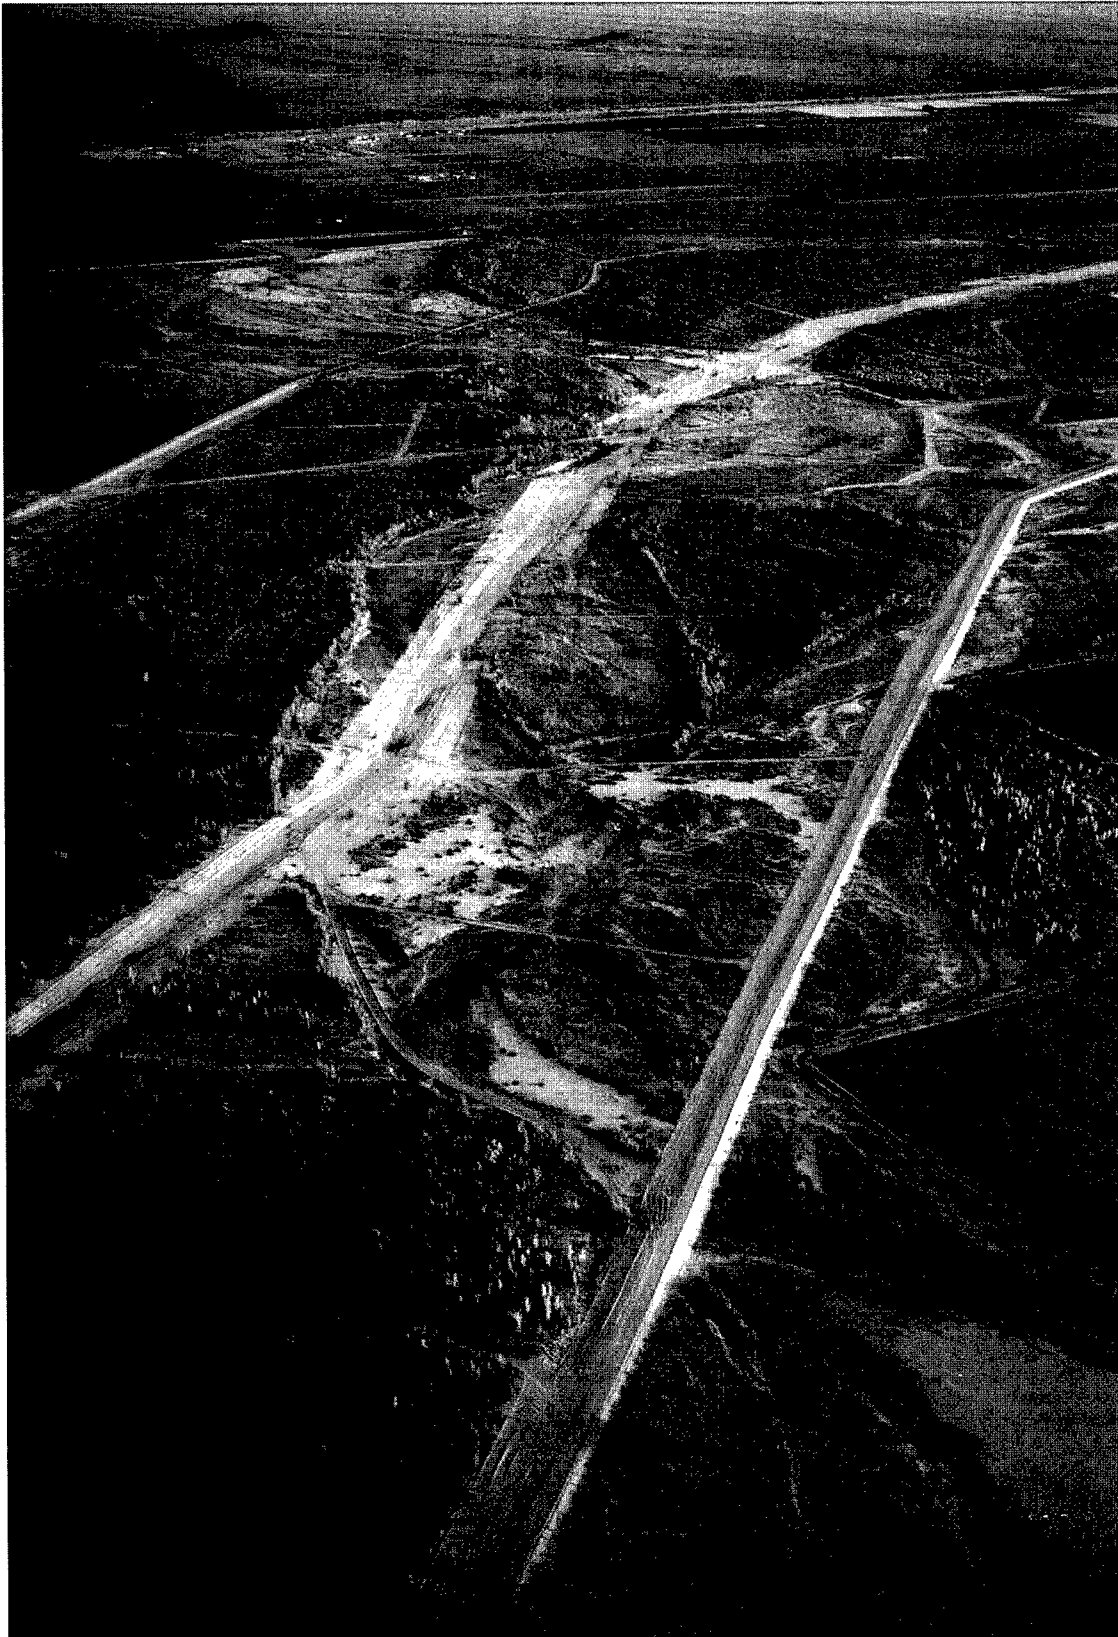
Fig. 42. Aerial view of the Gila River floodplain near Growler, Arizona. Photograph by Michael Collier.

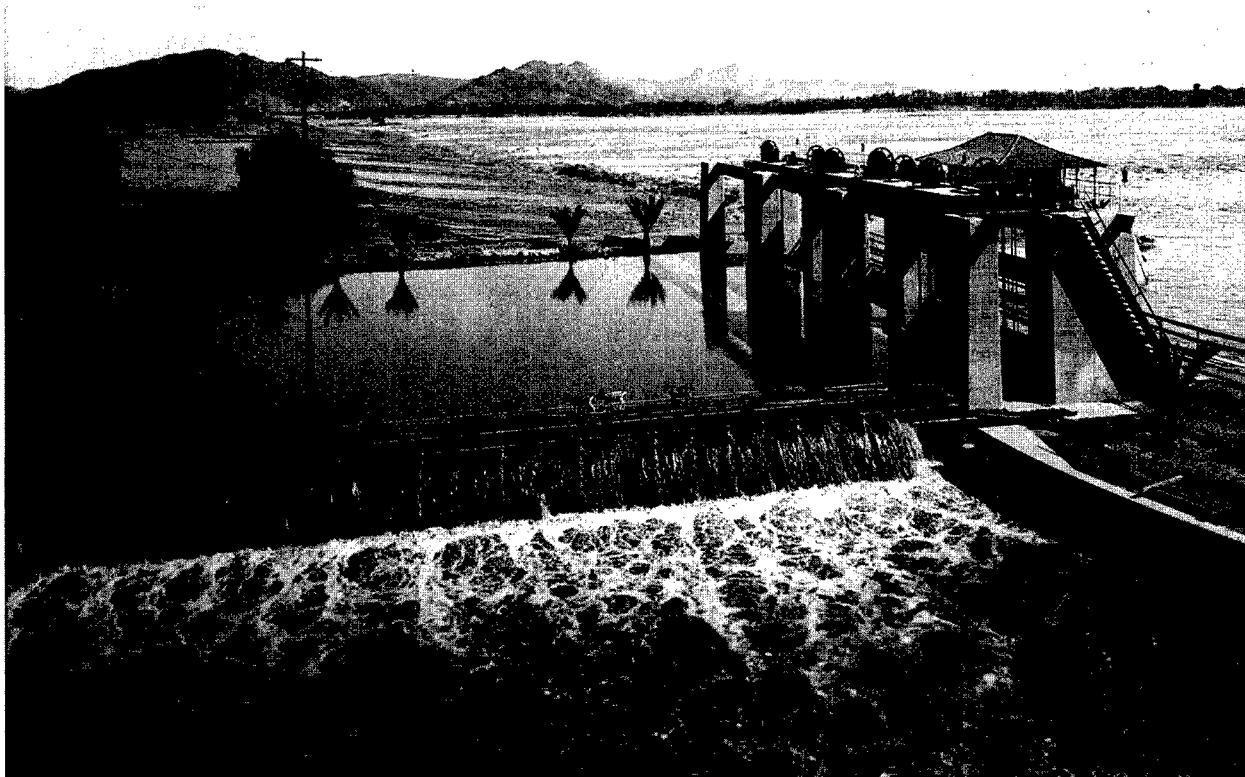
Fig. 63. The flood of 1922 breached the weir at Laguna Dam. Such floods were common until Boulder Dam was built in 1935, P45-300-4414A. Courtesy of the Bureau of Reclamation, Boulder City, Nevada.
